**DECOMMISSIONING OF
THE SOUTH BAY MINE
USING
ECOLOGICAL ENGINEERING

1994 FINAL REPORT**

M. Kalin

December 20, 1994

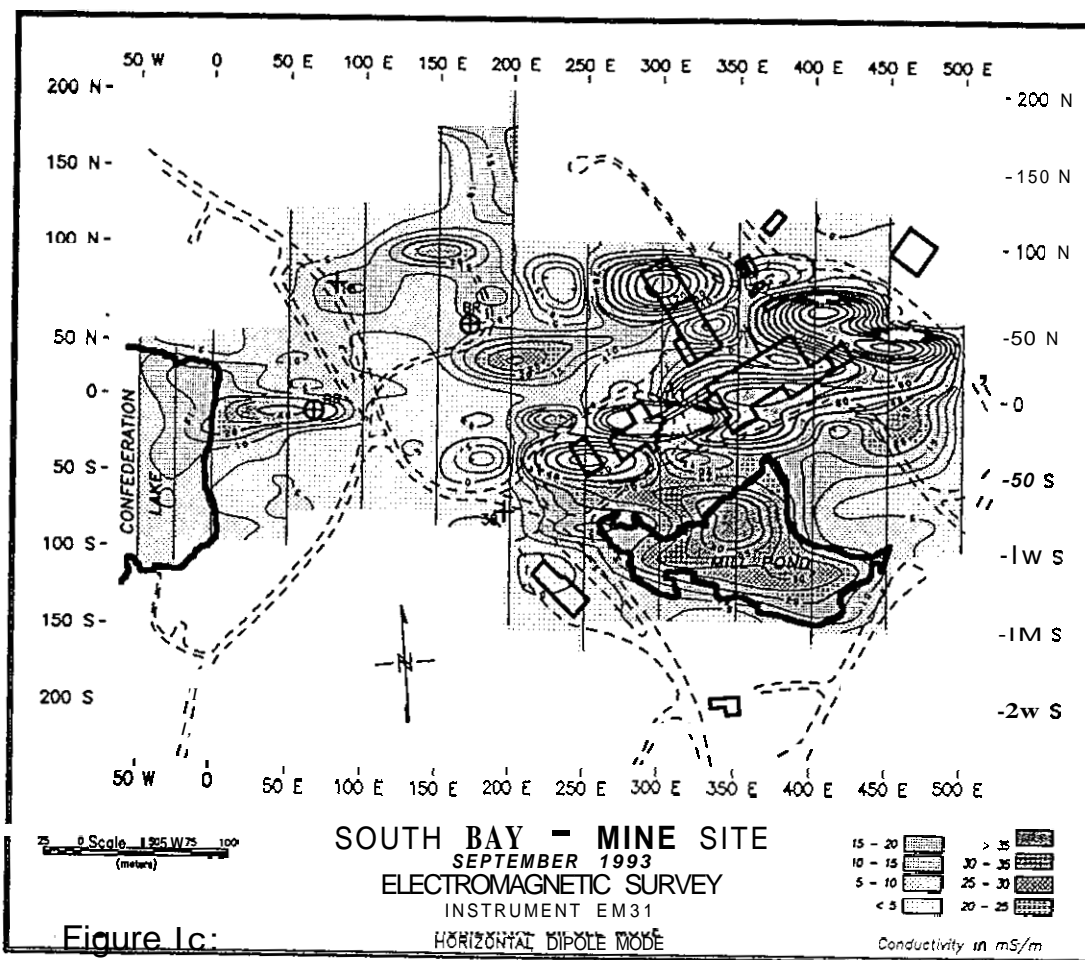
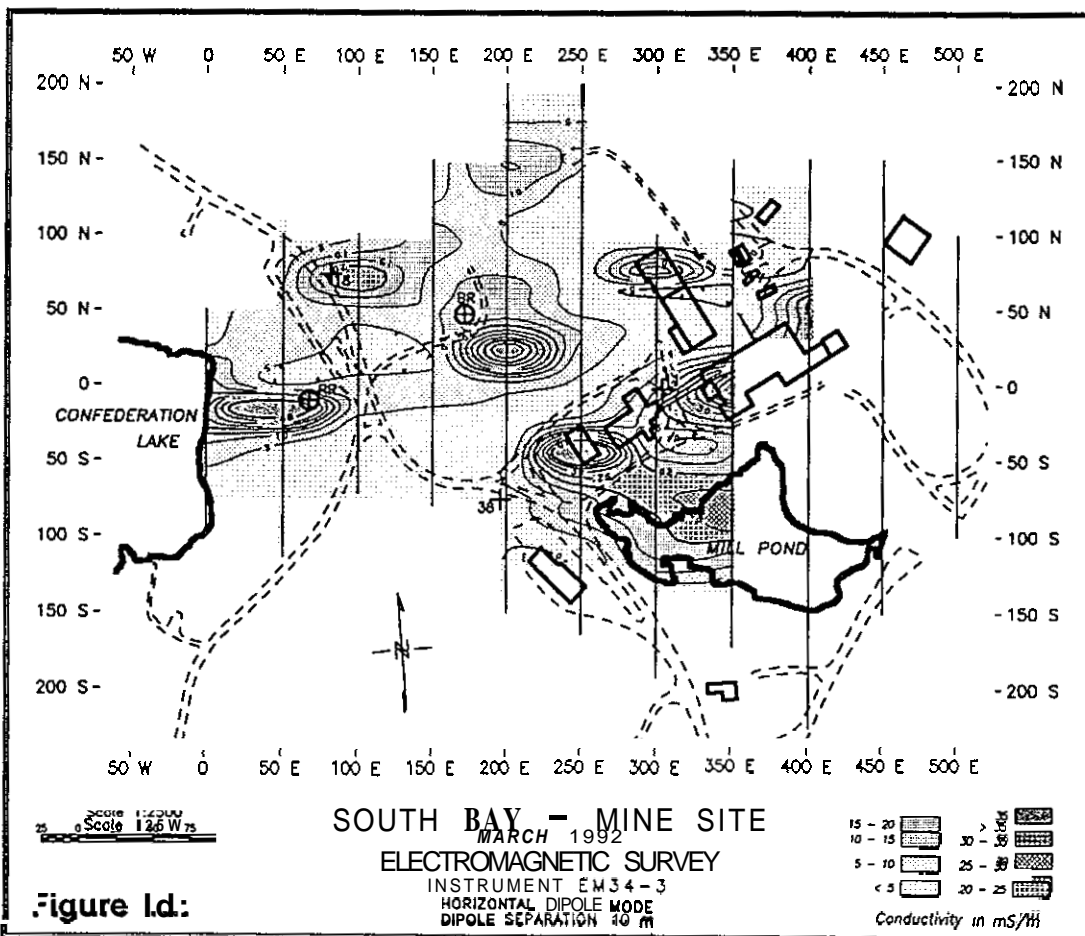
Figure 1b:

Both surveys depicted in Figure 1a and Figure 1b were conducted in the vertical mode to explore to a depth of about 6 m. A large seasonal difference is reflected in the increased conductivities in the immediate area of Mill Pond during the summer months. This is due to an increased water temperature and absence of the snow cover. The other anomalies described previously remained the same.

The results depicted in Figure 1c, represent a survey conducted in a horizontal mode with the exploration depth shallower, to about 2 m. Comparing these results with Figure 1b allows for an assessment of the portal seepage plume moving towards Confederation Lake. The shallow plume in the sediment at a depth up to 2 m extends over approximately half of the east shoreline of the small bay.

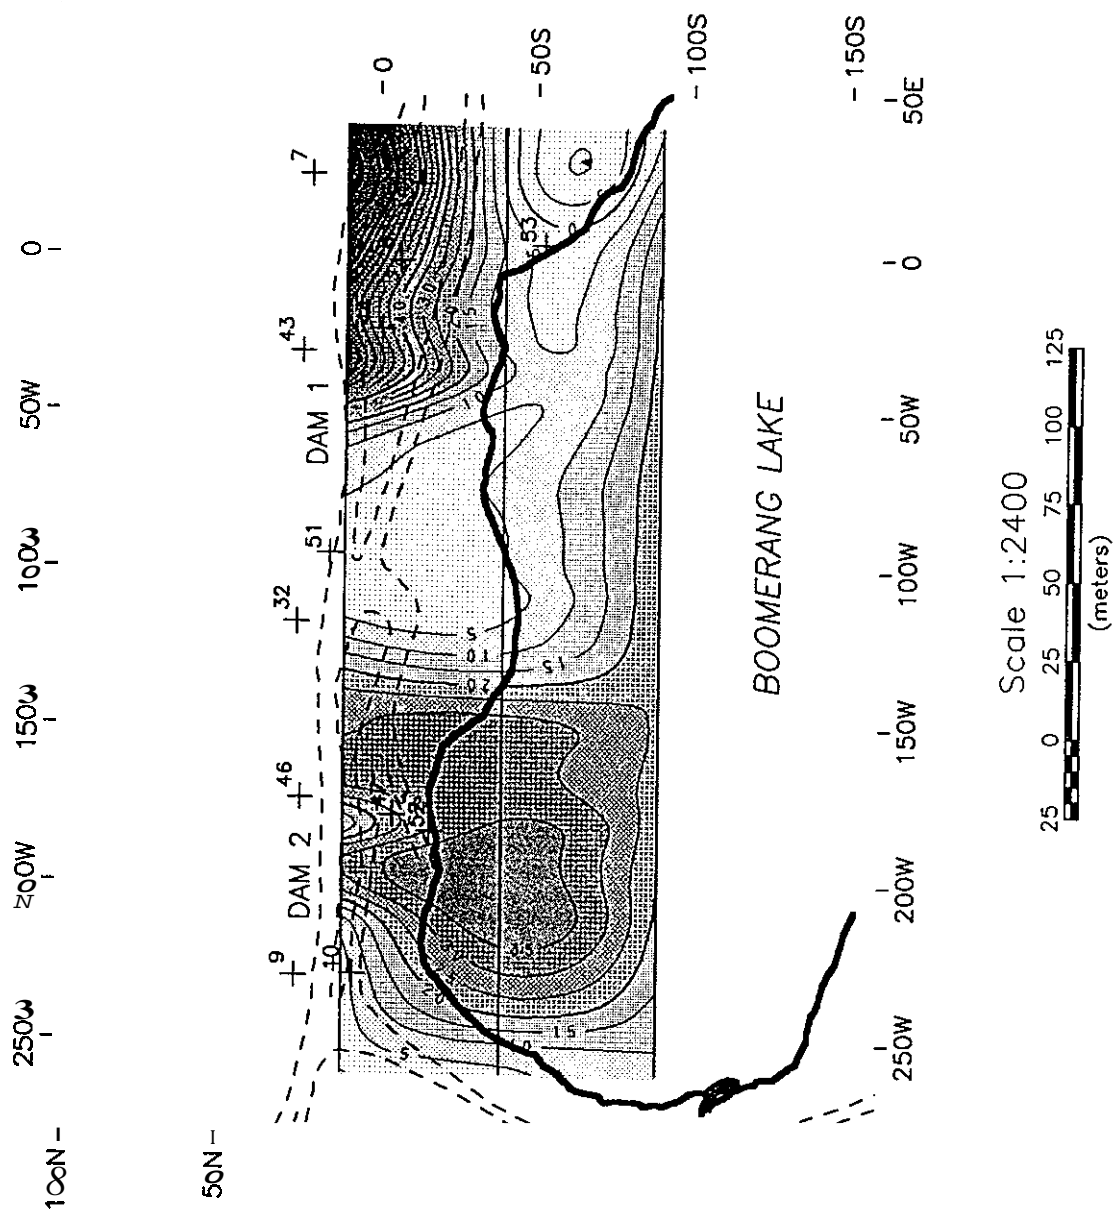
Figure 4a:

Two EM31 anomalies, one at each dam were identified. Visual notations of seepage at the shoreline below the dam in the area of the West Dam anomaly clearly indicate that the EM response is due to seepage from the tailings. This seepage is leaking through the West Dam between survey lines 150W and 200W (Figures 4a - 4c). In addition, anomalous responses between 50E and 50W suggest that additional seepages may also be passing through the East Dam at two locations, but are not as extensive as at the West Dam. A low conductivity response was returned from the outcrop area located between the two dams.

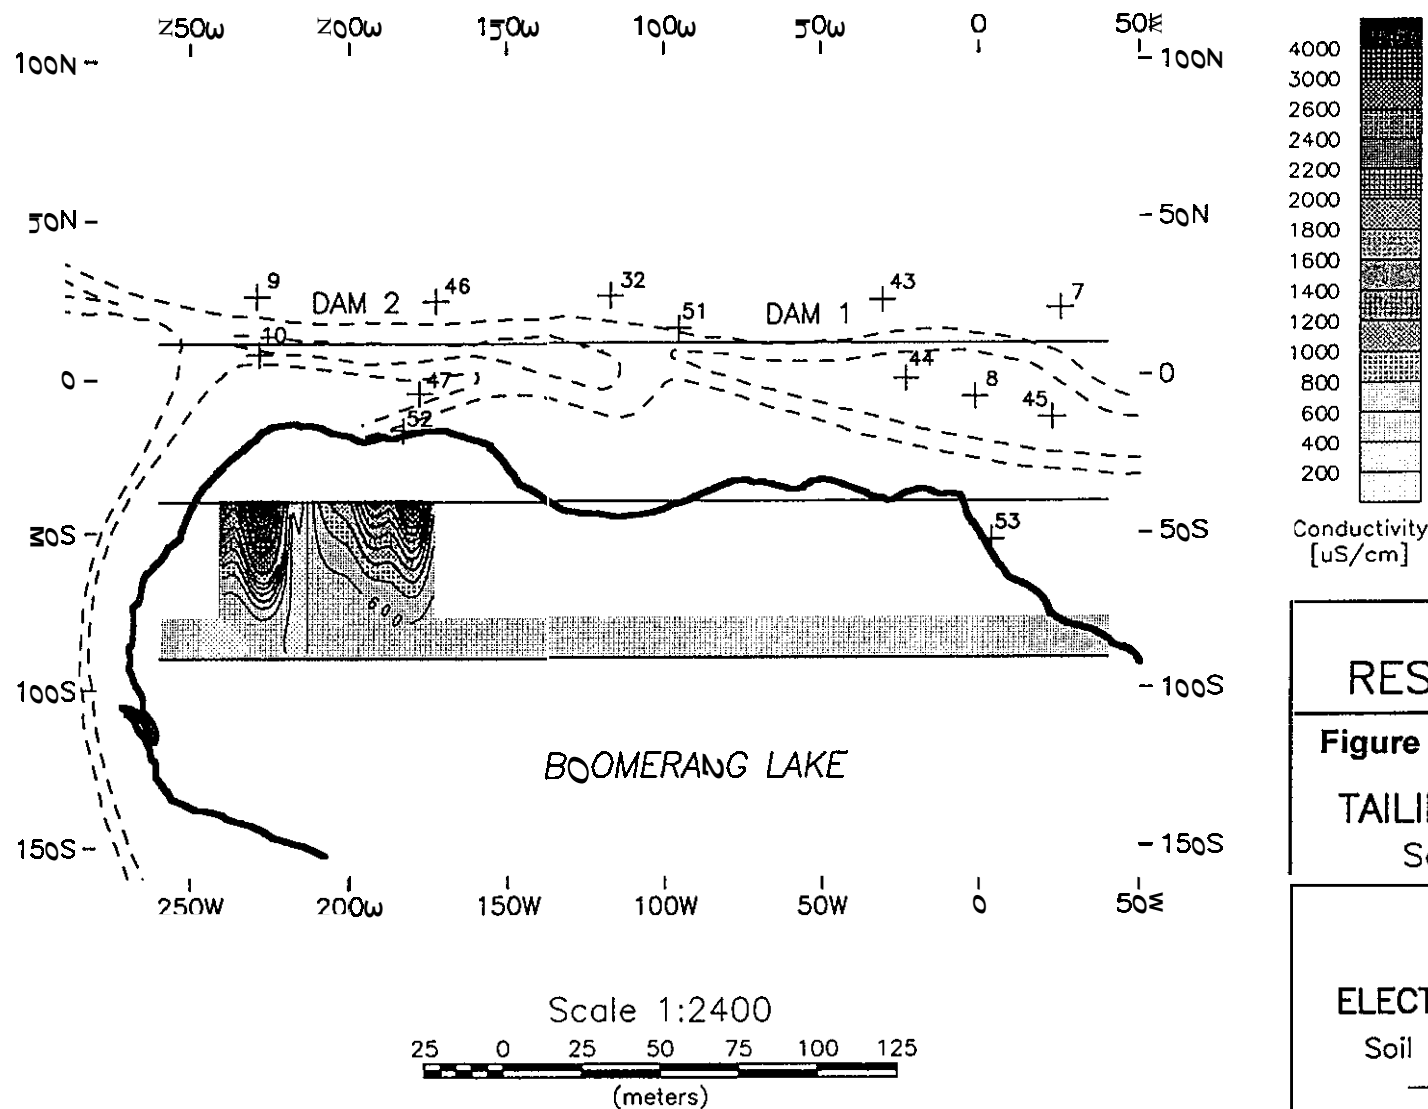
Figure 4d:
TAILINGS DAMS 1 & 2
September, 1993

The results of measurements of the specific conductance at the sediment-water interface (Figure 4d) verify the EM survey results. Specific conductance readings were high at the bottom of Boomerang Lake below the west dam, while the readings were homogeneously low at the bottom of Boomerang Lake below the east dam.

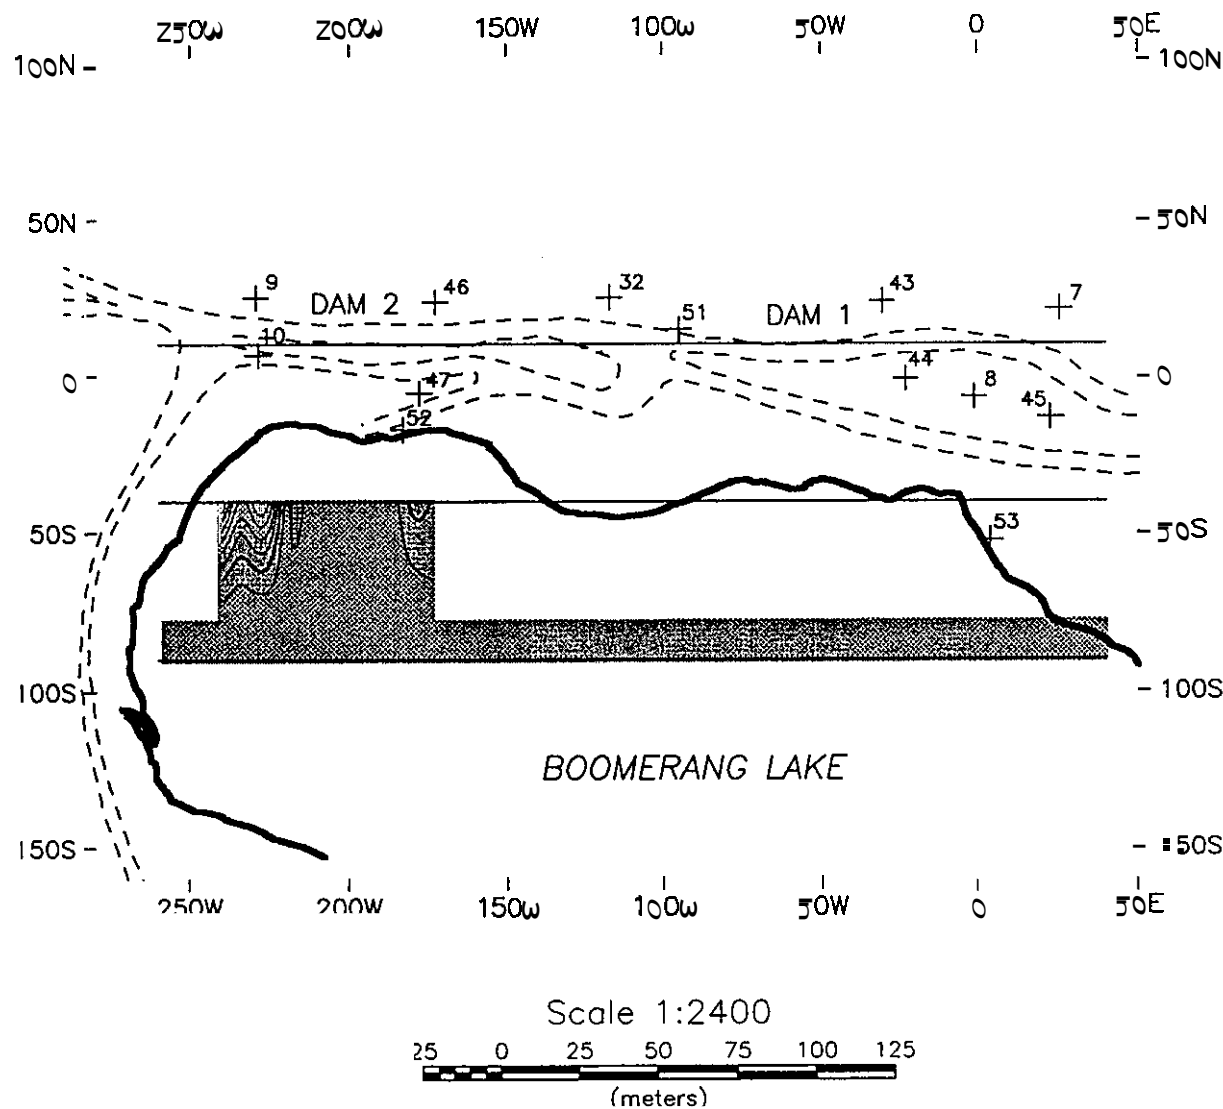
Figure 4e:

The pH of Boomerang Lake at the sediment-water interface was typically in the range of pH 3 to 4. However, the pH was 8 to 9 in one area near the shore below the West Dam. The high pHs are due to residual lime in sediments from treatment efforts in the 1980s.

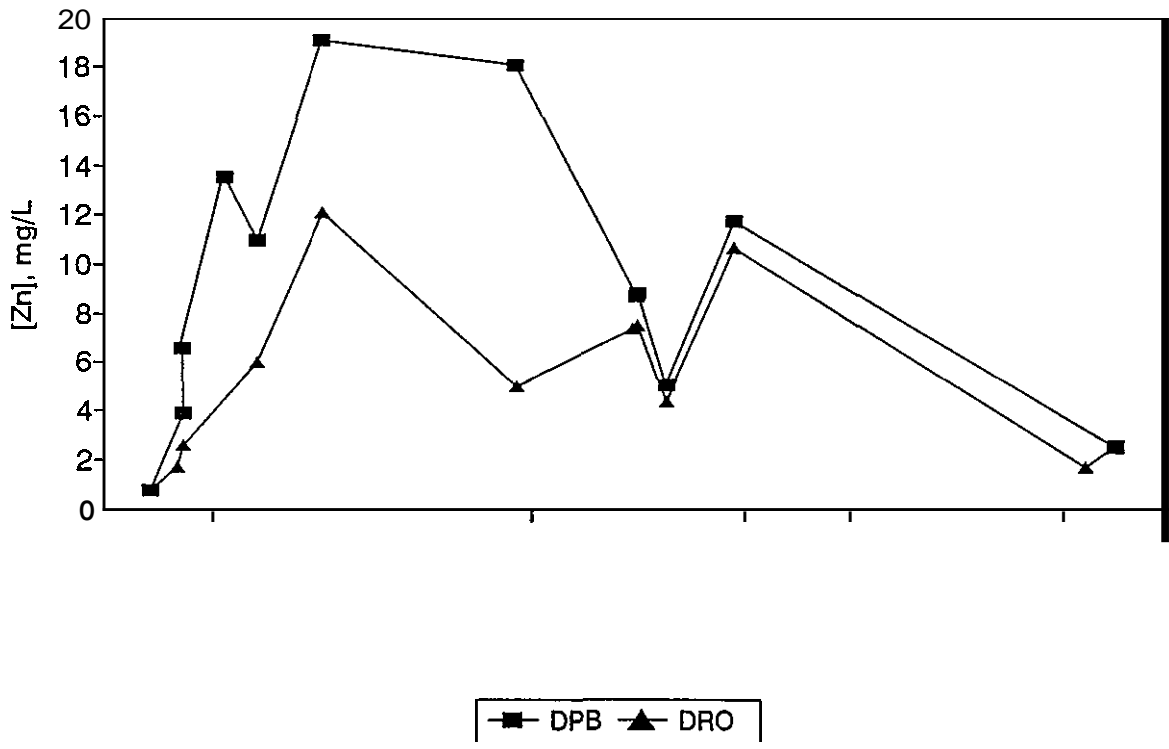
Fig.14: Decant Pond Beach and Run-off
Zinc Concentrations

It is evident that the zinc concentrations at the Decant Pond beach increased steadily in 1991 and zinc was removed significantly in the pond by biological polishing by the time the water reached the outflow. The reduction in pH resulted in diminishing the algal population on the beach, which were previously effectively removing zinc at a circumneutral pH range.

In 1992, remedial measures were taken in the tailings run-off and Decant Pond beach areas in order to reduce acidity and metal loadings to Decant Pond. These measures included distribution of natural phosphate rock (TRO-PPR) over the stream path of acidic drainage from the tailings (TRO), and the distribution of partially decayed wood slabs (wood waste) along the beach of Decant Pond. The locations are given in Map 3.

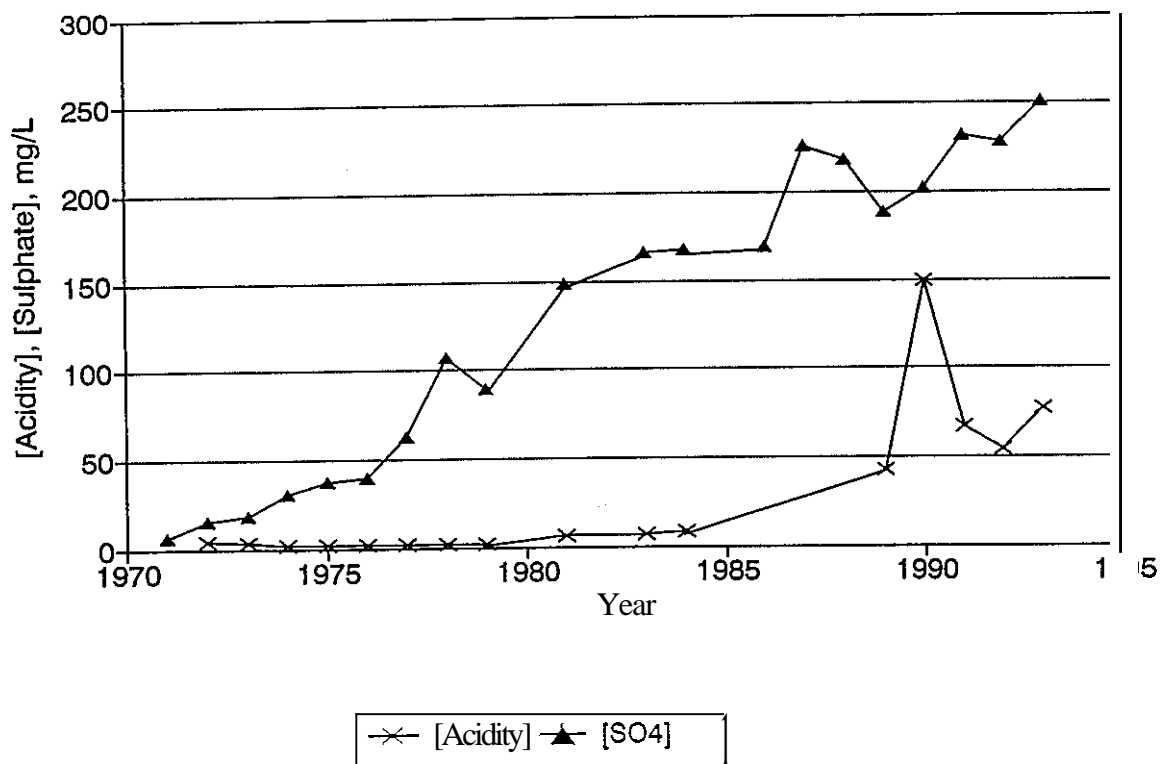
Fig. 18b: Boomerang Lake Annual Average
[Acidity] and [Sulphate]

Decreases in pH and increases in concentrations of iron, zinc, sulphate and acidity in Boomerang Lake between 1971 and 1993 are the result of input of contaminants from sources including the mill and tailings area. These changes are evident in Figure 18a and 18b. During these years, changes in contaminant loadings were offset to some degree by dilution by clean run-off, neutralization and precipitation by lime additions, and by physical/biological processes in Boomerang Lake's water and sediment.

The annual average pH of Boomerang Lake was above 7 between 1971 and 1974, typical for a natural lake in this region. However, the pH was variable and overall lower from 1975 to 1979. The annual average pH was relatively constant between 6 and 7 between 1980 and 1985, probably due to lime addition in Mill Pond, but suddenly dropped in 1986 to pH 4.3. The annual average pH has been steadily declining in the years since. The 1993, the average pH was 3.26.

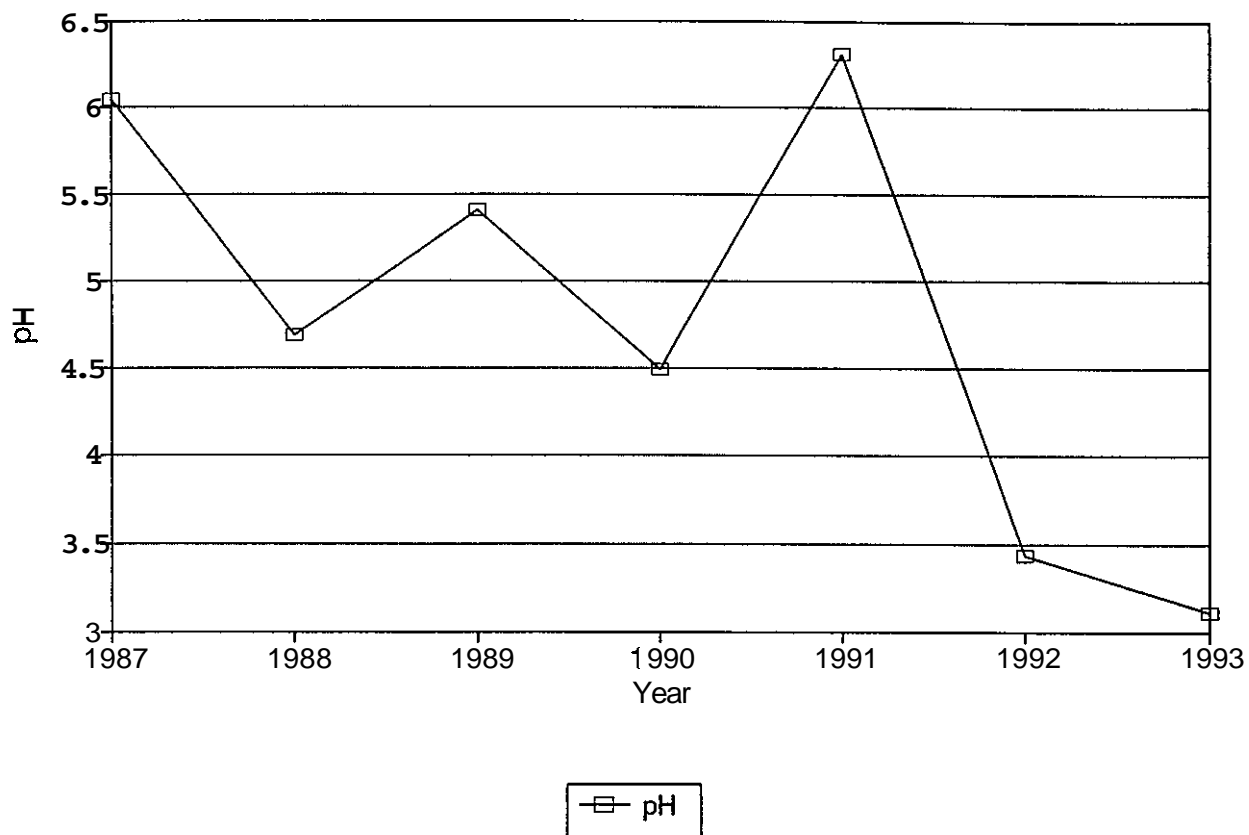
Fig. 21a: Tailings Div. Ditch Annual Avg
pH

The pH of samples collected from the ditch and the collection pond between 1987 and 1991 were greater than 4.5, while the pH of samples collected in 1992 and 1993 were much lower, at pH 3.4 and 3.1, respectively (Figure 21a). Similarly, the 1987 through 1991 samples contained much lower concentrations of iron (0.16 to 14.8 mg/L). The concentrations of sulphate (119 to 686 mg/L), compared to the 1992 and 1993 iron concentrations (526 to 804 mg/L) and acidity concentrations (1472 to 2785 mg/L) have also increased (Figure 21b). Clearly, the groundwater collected by the diversion ditch in 1992 and 1993 contained much higher contaminant concentrations than in the previous years. These changes were part of the reason to conduct the electromagnetic survey, discussed in Section 3.4.
